Service Bulletin

Subject: Mag Timing Housing- Dowel Pin

Date: 02/23/2017

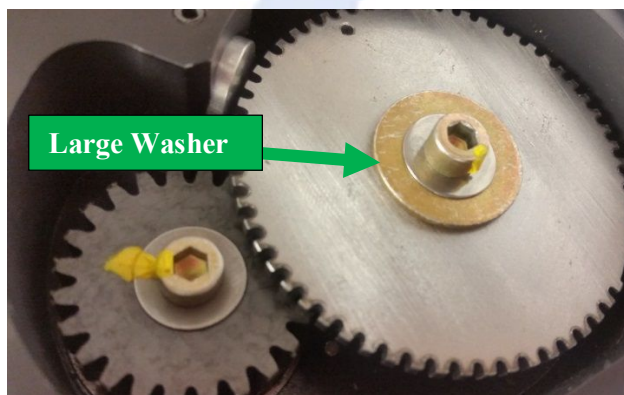
Owners and operators of aircraft equipped with the referenced EA-10000 or EA-12000 6-cylinder Mag Timing Housings (MTH) can inspect the MTH to see if it has already been modified. To check for the modification, first remove the bottom cover of the MTH unit. Use caution with the screws, because those are brass screws which can easily be cross threaded. Once the cover has been removed, simply visually inspect the top of the trigger wheel. If you see a large washer under a smaller washer and screw, then the MTH unit already has been modified (Figure 1). If you see only a small washer and the dowel pin, then the MTH has not been modified (Figure 2).

Figure 1: Modified MTH

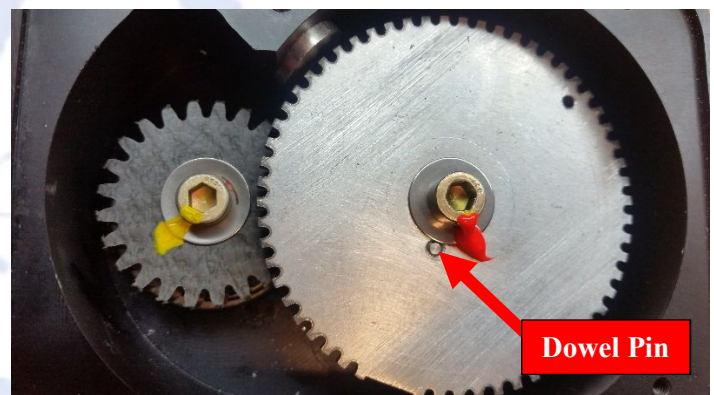
Electroair has received reports of the 6-cylinder Mag Timing Housing (MTH) malfunctioning. The malfunction may cause the trigger wheel within the MTH to become loose due to a dowel pin withdrawing from its designed position. If this happens, the electronic ignition system may not function correctly. The engine timing from the electronic ignition system may slip, and the engine may run rougher than normal. A pilot may notice either a rough running engine, or may notice slightly elevated or slightly decrease cylinder head temperatures.

Figure 2: MTH without Modification

If your unit (Figure 2) contains only a small washer, and you can see the dowel pin, then your unit should be returned to Electroair for service and modification.

What Electroair will do: Affected serial number Mag Timing Housing (MTH) unit owners should contact Electroair and schedule the modification. Units that have NOT been modified with the larger washer may be returned to Electroair for modification/alteration to be configured into the latest design. There will be no charge for this modification.
