Service Bulletin # 1019-0002

Date: January 29, 2024

Subject: 6-Cylinder MTH Assembly: Part Numbers EA-12000, EA-16000, and EA-25000

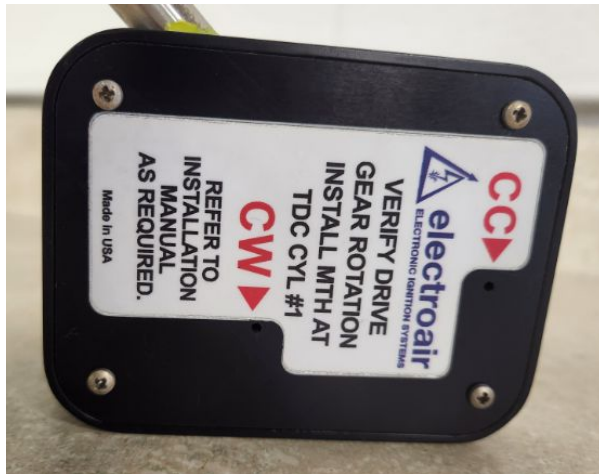
Figure 1: EA-12000 and EA-16000 Cover Plate

Owners and operators of aircraft equipped with the referenced EA-12000, EA-16000, or EA-25000 6-cylinder Mag Timing Housings (MTH) can inspect the MTH to see if the gears are damaged. To check for possible damage, first remove the bottom cover of the MTH unit. The MTH cover has four screws that must be removed to take off the cover plate. Once the cover has been removed, simply visually inspect the gears inside. If you see damage or the possible start of damage, contact Electroair to get assistance with the necessary steps for having the EA-12000, EA-16000, or EA-25000 modified.

Electroair recommends that owners and operators of aircraft equipped with the referenced EA-12000, EA-16000, or EA-25000 6-cylinder Mag Timing Housings (MTH) without the modification and have been operating for less than 50 hours, contact Electroair to get assistance with the necessary steps for having the EA-12000, EA-16000, or EA-25000 modified.
