# My experience with the Electroair Dual EIS Installation

The aircraft is a 1979 TR182. We have flown it since 2009 and have flown over 700 hrs. without incident. The total time on the airframe is about 4000 hours. My motivation for the installation of the Electroair dual system was and is Safety. The additional power and fuel savings are a bonus in my case.

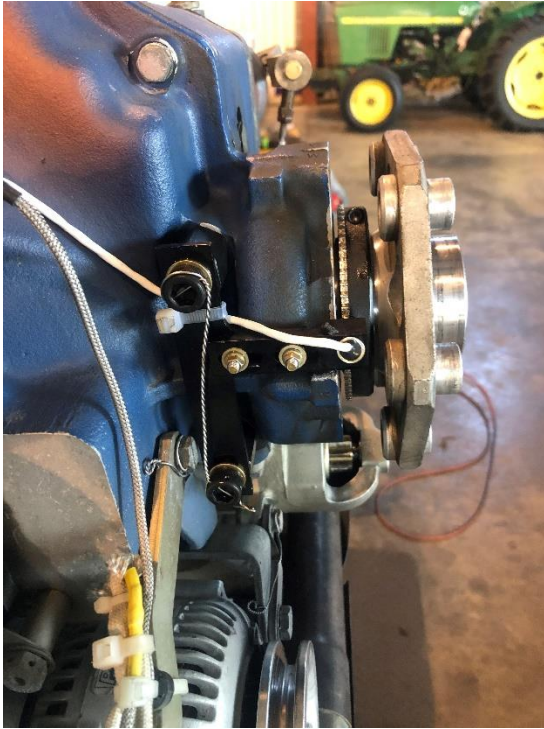
CrankShaft Trigger Wheel and Sensor

It is vitally important to get the system timing right (#1 TDC,  $\pm 0.5^\circ$ ). Therefore, time the engine with an inclinometer on the propeller. This will time the engine to TDC #1 very accurately. You can use other methods, but in my opinion, they are far less accurate. Next install the MTH per the manual. It installs where your dual mag used to be. This will enable you to use the MTH to "find" TDC when the propeller is removed. My engine flywheel must be removed to install the CSTW and Sensor. You do not want to do this twice.

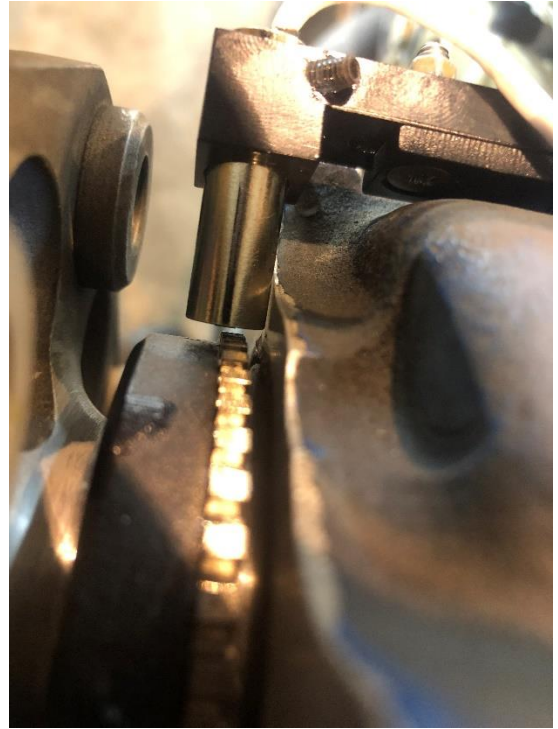
Closeup of CSTW Sensor alignment

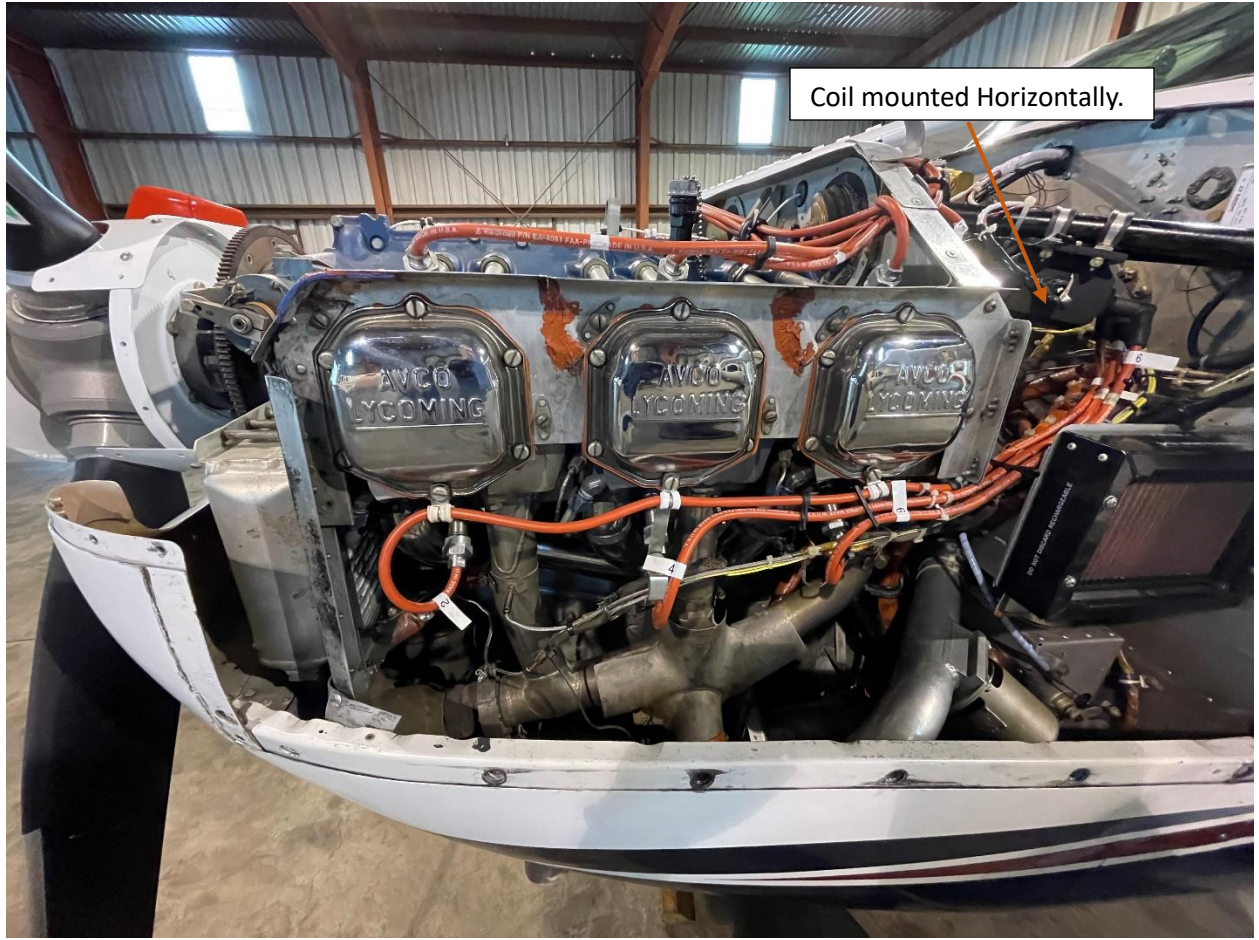
It is also crucial to ensure that the CSTW / MTH sensor wires do not come within 1 inch of the spark plug wires, **period**. The CSTW sensor will probably require a new penetration through the rear metal baffling and a grommet. Ensure these wires are secured so that they cannot move within 1 inch of the spark plug wires (zip ties).

CSTW Sensor routing (white wire) around sparkplug wires

The first start was exciting. The engine started but only one of the EIS systems provided spark. We found the cable from the MTH to the control box had failed at the connector. A replacement was sent and installed. At this point, we rerouted the signal cable from the CSTW sensor to ensure it did not receive electrical interference for the spark plug wires.

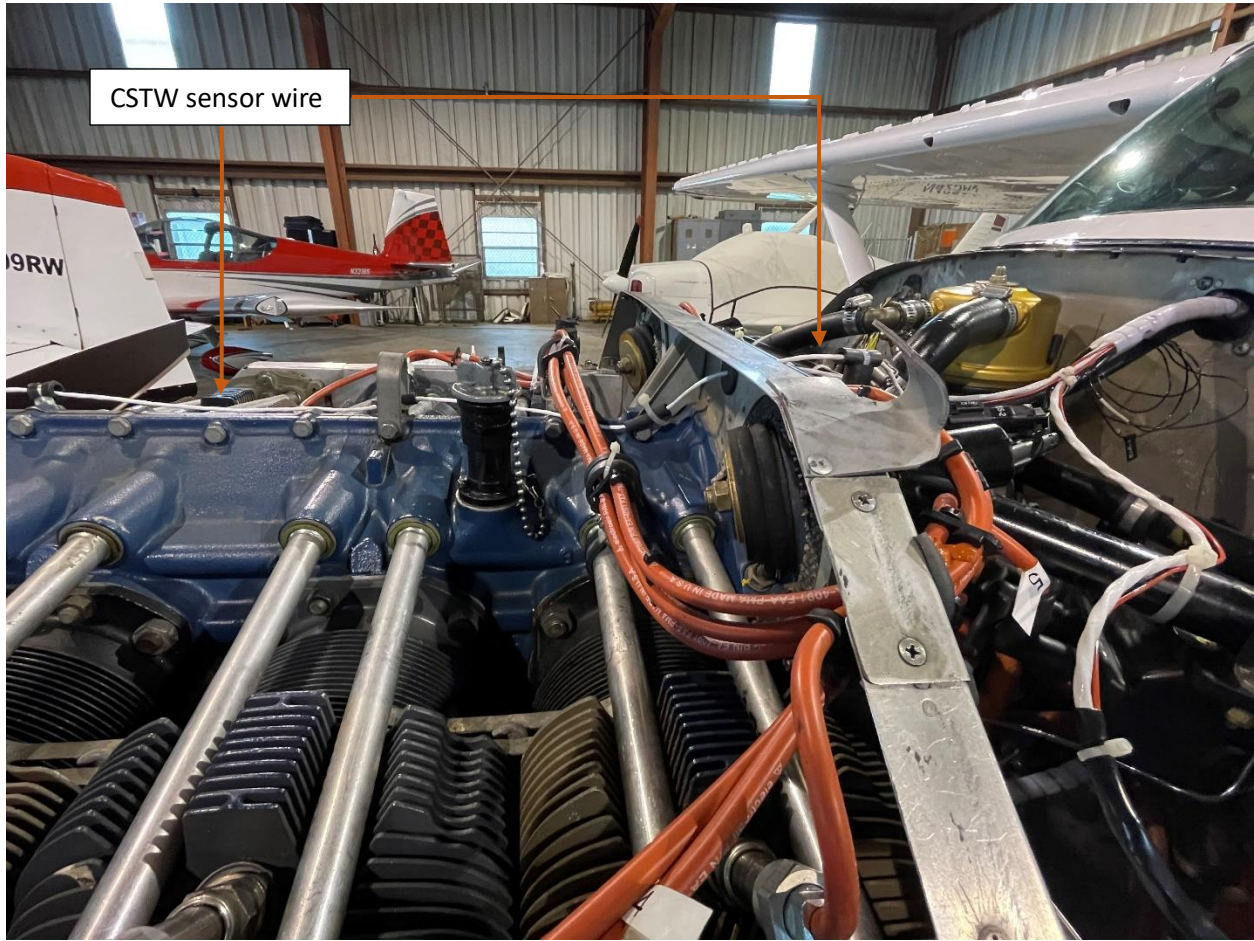
Electroair cable harness routing through the firewall

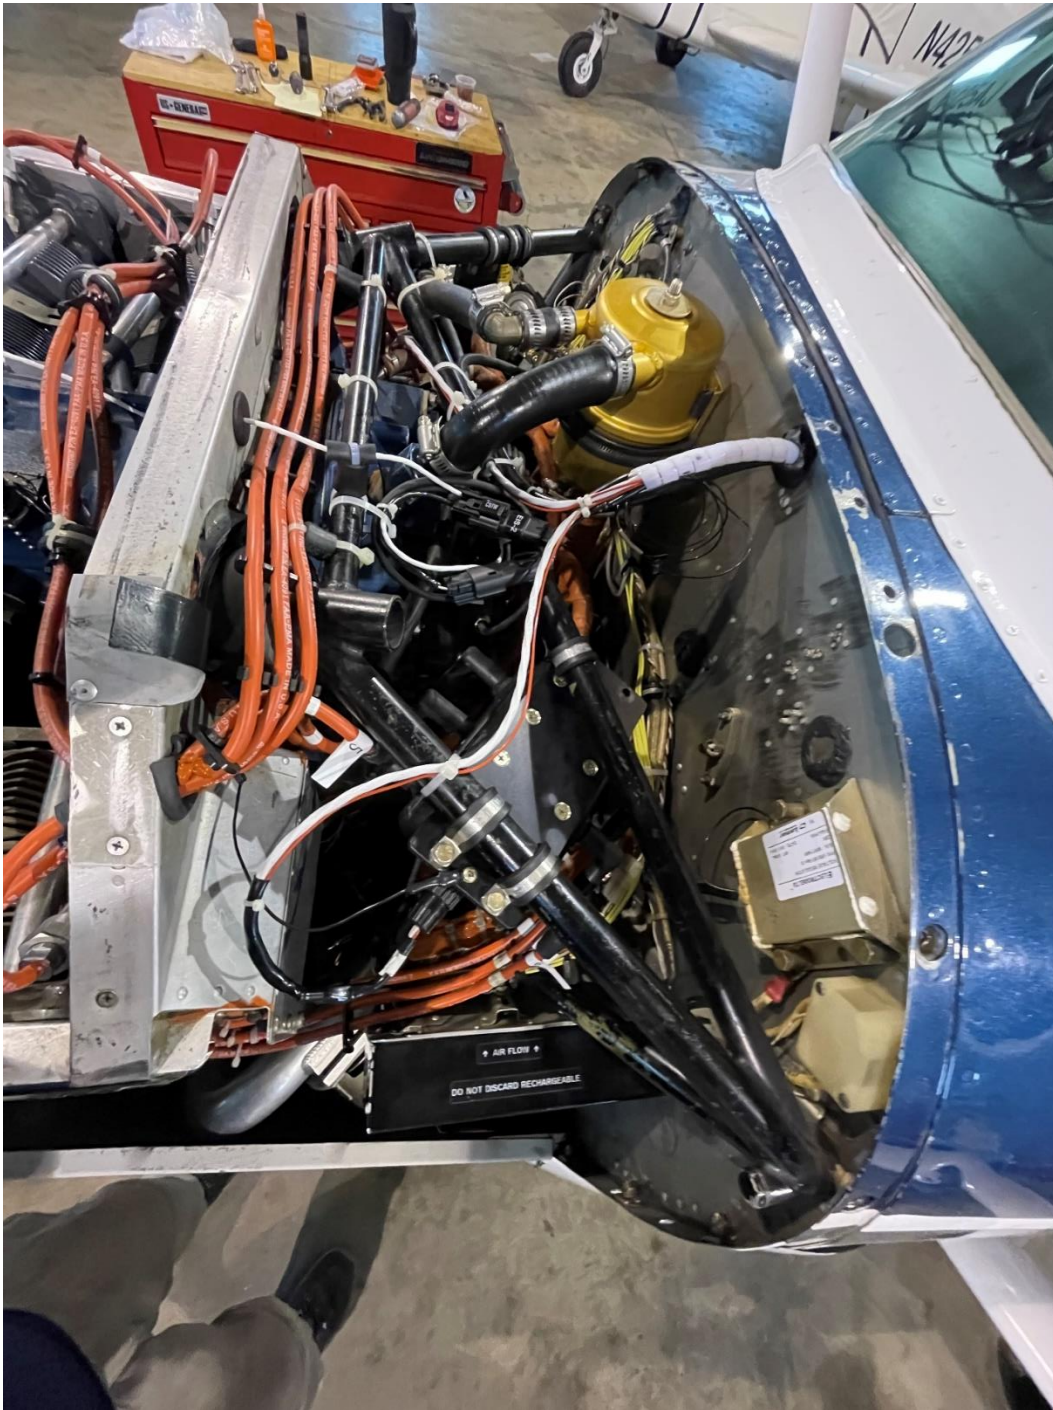
Closeup of cable routing showing EIS-1 and EIS-2 connectors to the main harness

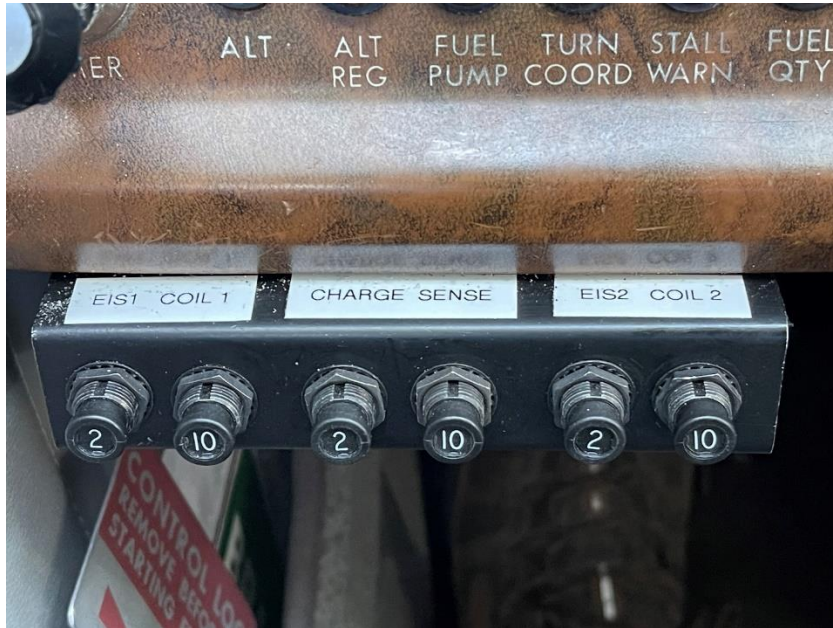
I have installed upgraded avionics in my airplane. Therefore, there was not room for the required Electroair circuit breakers on the panel itself. You may have to fab a separate circuit breaker panel. See pictures.

Breaker Panel for the required Electroair breakers, fabricated from Aluminum sheet

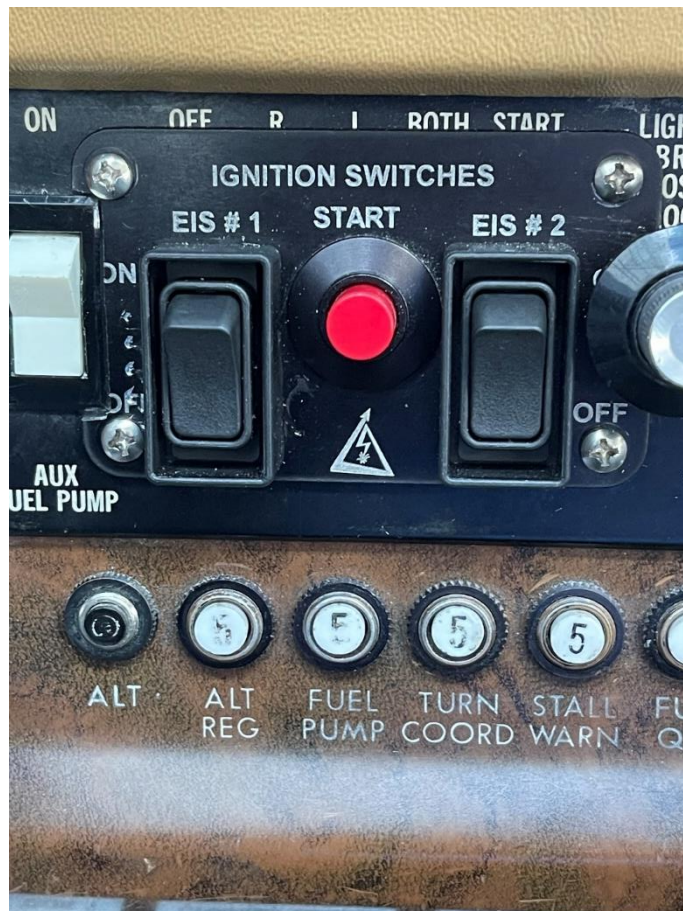
On an R/TR 182 the EIS switch panel requires fitment (Dremel tool) to fit into the ignition switch hole / opening. It is tight and this could use some design improvement. See pictures.

EIS Switch Panel, notched to fit the Cessna Key hole area

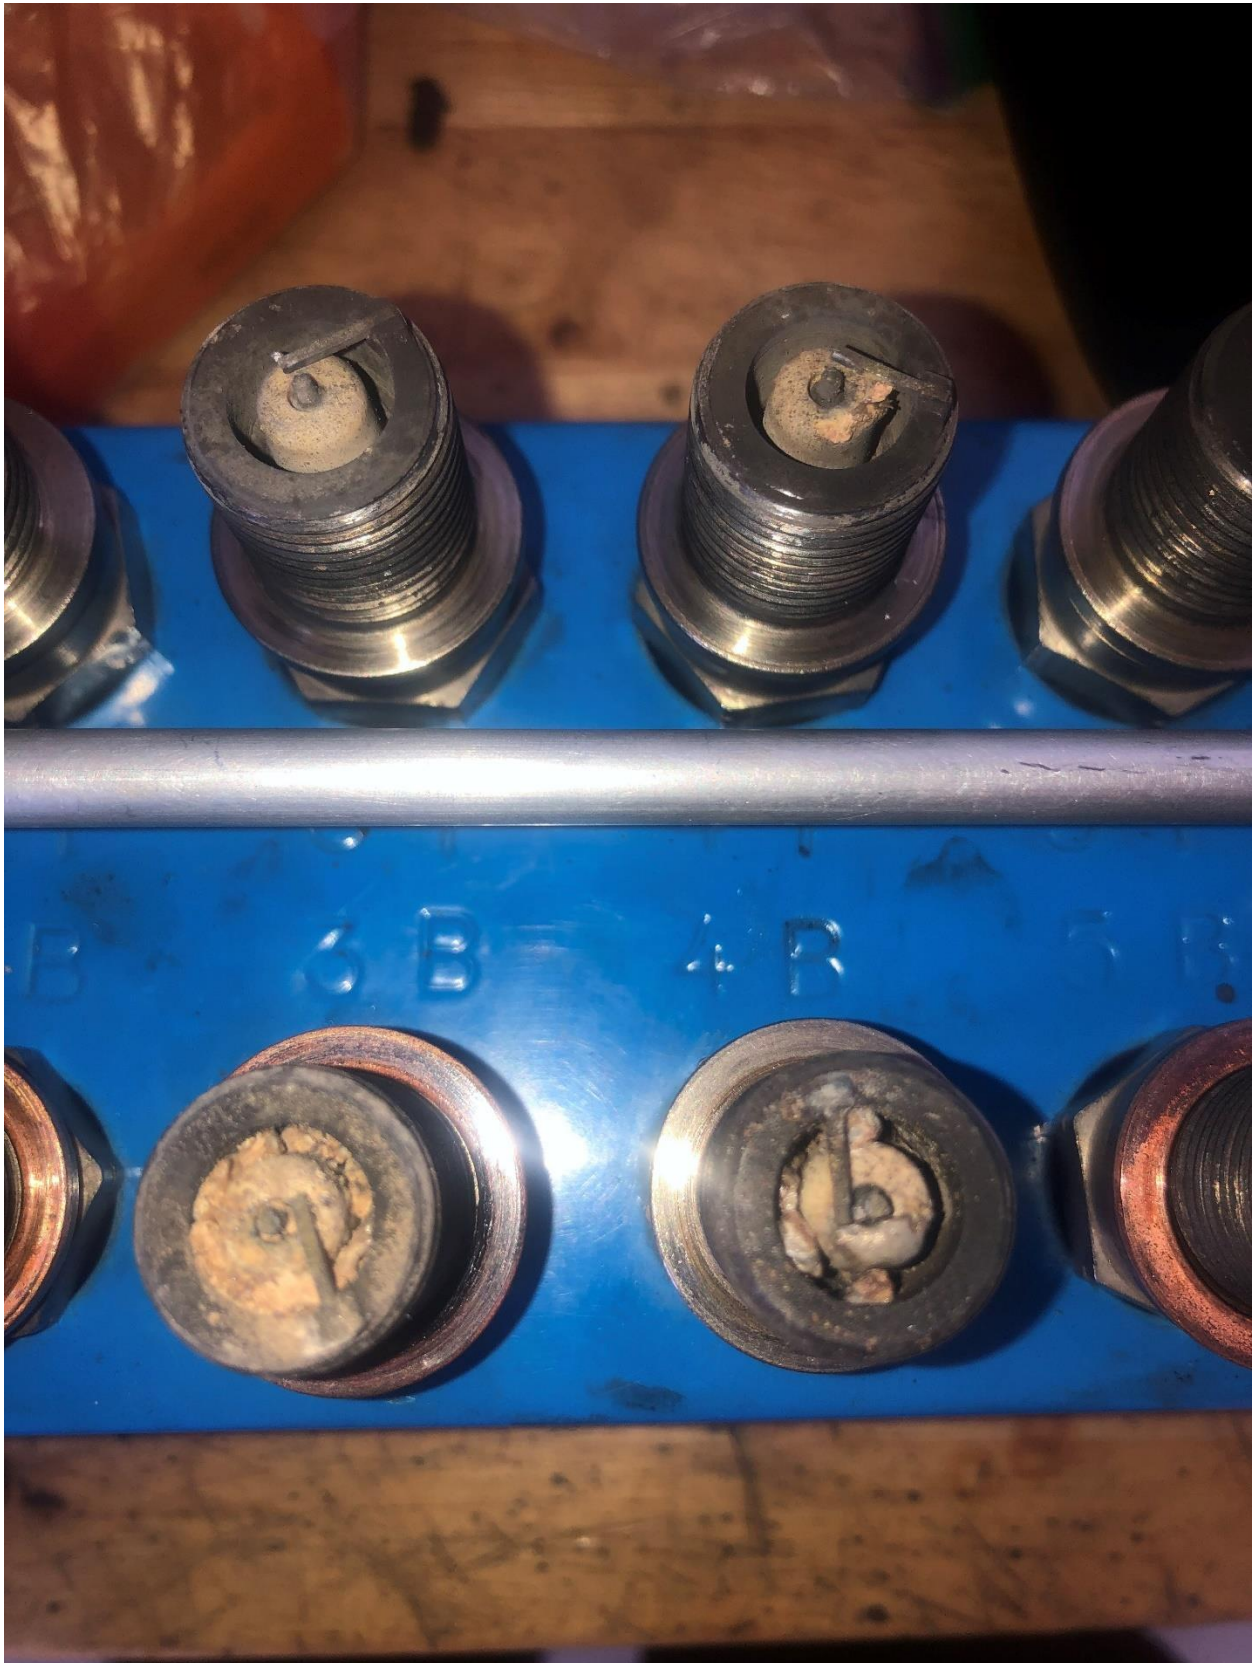
The CHTs steadily rose beyond normal. The highest cylinder reached 435°F. This was atypical for my powerplant. We made a landing to troubleshoot the situation. We found several spark plugs fouled with lead combustion products. #4 upper spark plug was bridged from the center electrode to the side electrode. The engine has fine wire plugs installed in all positions.

If your engine is high time, you can expect some piston and combustion chamber cleaning. The lead deposits are "cleaned" from these areas by the heat of combustion. This will continue for 2-7 hrs. of operation. This depends on the amount of lead deposits in your engine. You will have to clean the plugs during this period. Alternatively, Lycoming has a Service Instruction for cleaning the combustion chamber, S.I.-1418. It directs the use of walnut shells to remove the combustion products (carbon and lead compounds). This is basically a walnut shell blasting of the piston top, valves and combustion chamber. I would recommend this if your engine is high time.

Fouled Sparkplugs After First Flight
