EIS-41000 Instructions for Continued Airworthiness

Electroair Acquisition Corp. Revision 09 ICA EIS-41000 Prepared by: EAC Page 1 of 19 12/17/2021

This Instruction for Continued Airworthiness contains the necessary information required for the maintenance of the electronic ignition system (EIS) approved for installation in accordance with STC SA02987CH. Electroair is responsible for this document and any changes to it will be made electronically.

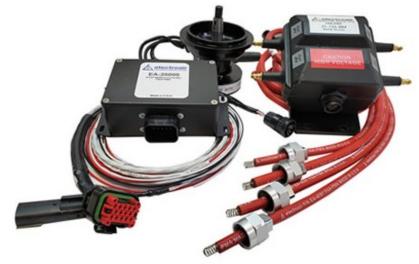
Figure 1: EIS-41000 Kit

For STC SA02987CH, the Electroair EIS-41000 Electronic Ignition System can be used as a single magneto replacement, or with certain limitations, can replace both magnetos. An aircraft equipped with an EIS-41000 and a single magneto or two EIS-41000s will make up the dual ignition system. The EIS-41000 kit consists of the following components: Controller (EA-2000), Coil Pack (EA-2000), Spark Plug Wires (EA-4000), Wire Harness (EA-22000), and Trigger Mechanism (EA-3000(LH)(IC)).
